# Manhole Inspection Summary

Manhole # S45EE\_050MH

Insp Date: **3/10/08 11:03 AM**

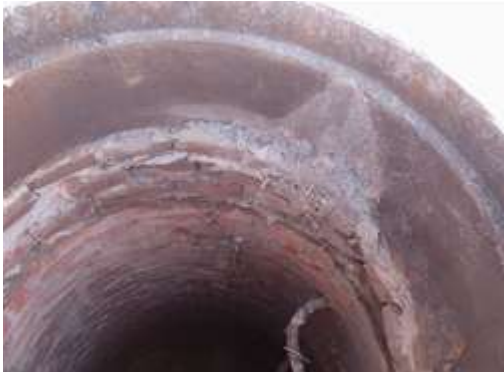
Defect 2

**Frame** Offset: **1** (in.) Condition: ☐ Sound ☐ Cracked ☒ **Leaks**

frame leaks

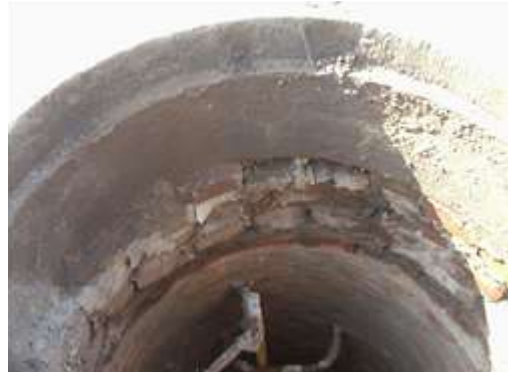
Defect 1

Condition: ☐ Sound ☐ Cracked ☐ Root Intrusion ☒ **Loose Brick** ☐ Deteriorated

adjustment joint

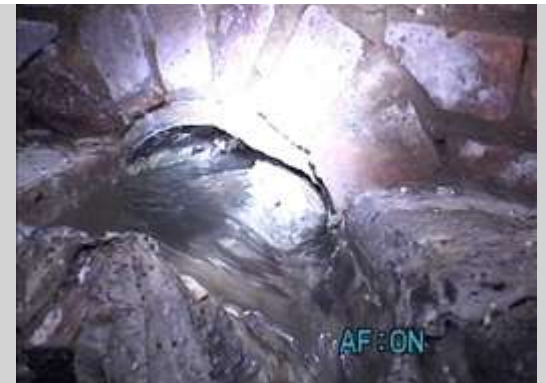
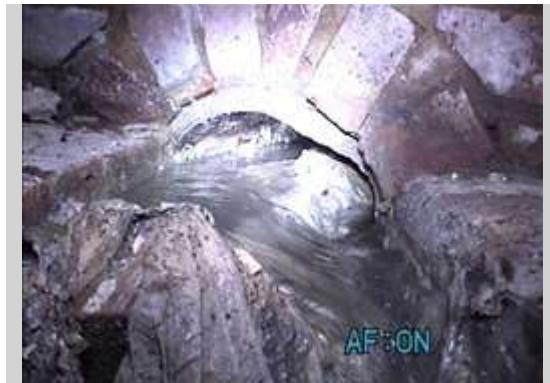
8 O'Clock Inflow

Pipe Height: **8.4** (in.) Rod and Bar (Angled)  
Pipe Material: **Clay** ☐ Pipe Lined  
Invert Depth: **11.15** (ft.) Flow Characteristics: **Fast**  
Deposits: ☐ None ☐ Mud ☒ Sludge ☒ Debris ☐ Grease  
Silt Depth: **5** (in.) Deposits Extent: **Heavy**  
Infiltration: **None** Pipe Seal Cond: **Sound**
